Proposed UK Holocaust Memorial and Learning Centre, Victoria Tower Gardens, Millbank, London SW1P 3YB

Supplemental proof of evidence

in respect of arboriculture

Date: October 2020

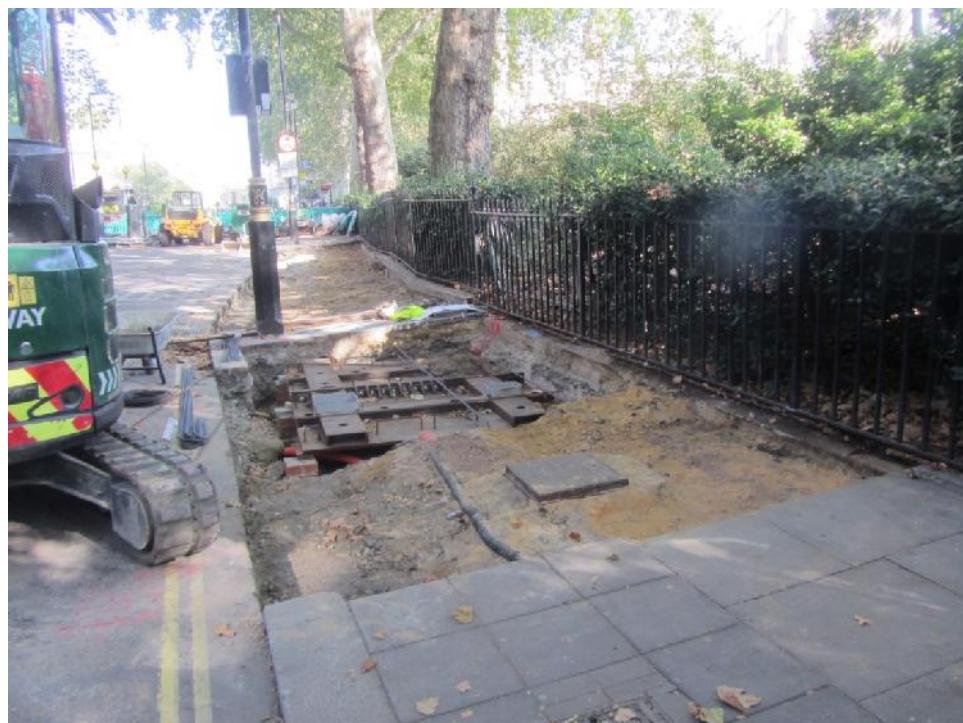
3.1.2 As part of these works, I saw that a section of the pedestrian footway on the east side of Millbank had been taken up by the removal of the paving slabs over a distance of approximately 20-25m, from a point slightly north of the position of the trunk of tree 71009, up to a point close to tree 71007. The kerb edgings along the edge of the Millbank carriageway had also been removed. Within this section, towards the southern end, a rectangular excavation had been dug to a depth of approximately 800mm, of around 5m in length, and across the full width of the footway, exposing the face of a stonework foundation to the plinth supporting the metal railing boundary fence of VTG. Within this excavation, a fabricated steel base had been set, levelled on supporting low brick piers, and surmounted by reinforcing caging (*Photo 1*).

Photo 1. Works in footway of Millbank adjacent to VTG, general view.

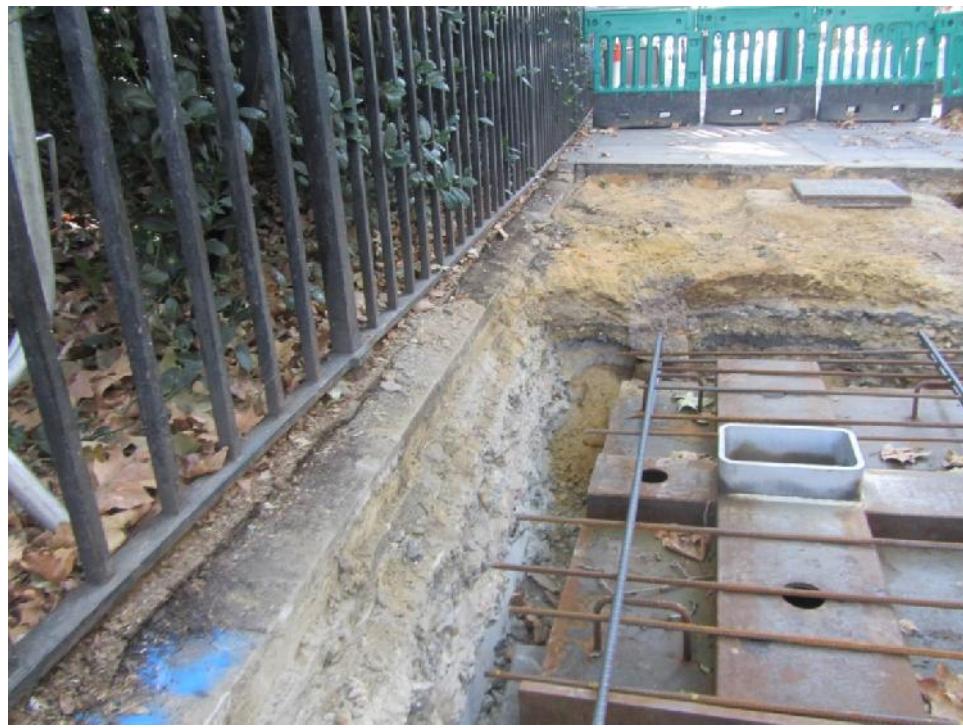
3.1.3 Examination of the side of the excavation along the VTG boundary showed the construction of the stonework foundation extending to the full depth of the excavation, and projecting outwards from the line of the plinth and metal railing fence above (*Photo 2*). The sub-base beneath the removed paving slabs also extended to the full depth of the excavation, comprising compacted layers of stone, clay and cement rubble and hardcore. Despite the proximity of the excavation to the trunks of trees 71009 and 71008 (being roughly halfway between them), no roots were seen to be growing through the stonework foundation wall, and minimal root growth (two roots of c.3mm diameter) was seen within the compacted sub-base layers of the pavement in the southern face of the pit (*Photo 3*).

Photo 2. Excavation in Millbank footway, showing stonework foundation below VTG fence.

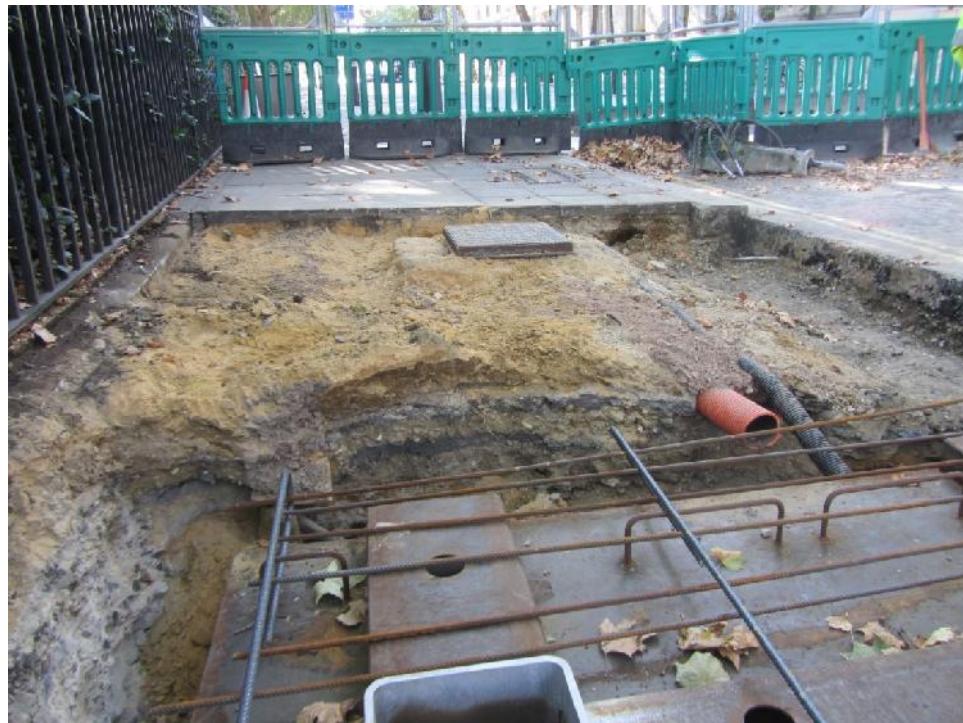
Photo 3. Excavation in Millbank footway, detail.

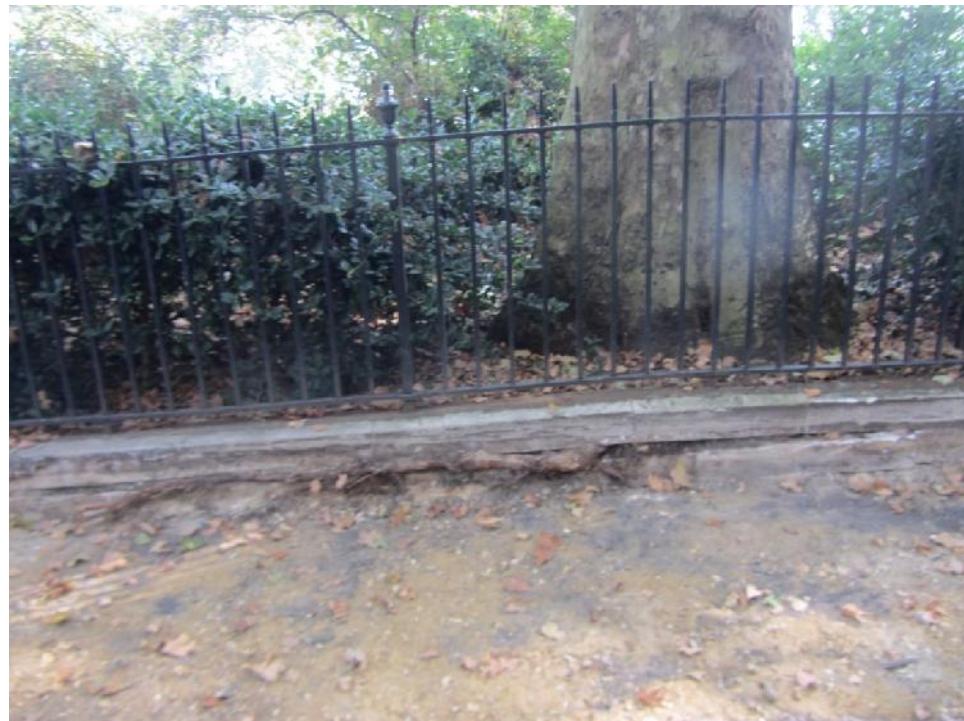
- 3.1.4 At the base of tree 71008, I saw one root had grown through into the area of the footway between the top of the stonework foundation wall and the above ground plinth, of approximately 50mm diameter at its point of emergence from the wall

and of around 1.5-2m in length, tapering to less than 25mm diameter at its severed end, and running northwards closely along the line of the capping course (*Photo 4*). This was the only root of any significant size I observed.

Photo 4. Single root from tree 71008 between plinth and stonework foundation.

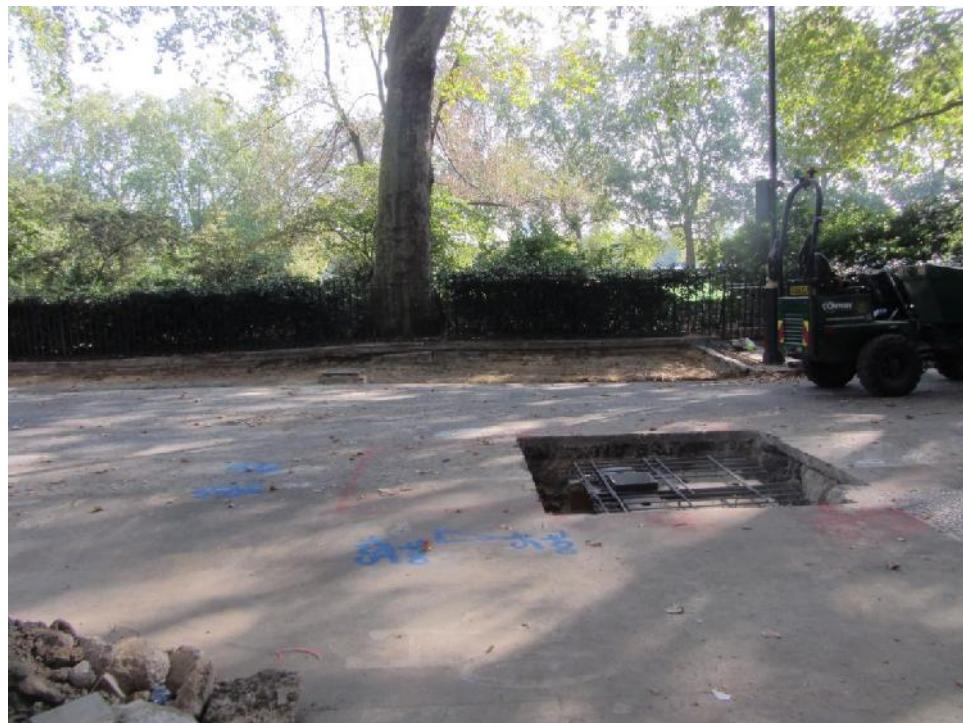
- 3.1.5 *Photo 5*, taken from directly opposite tree 71008, shows bowing and uplift of the plinth and stonework foundation wall centred on the position of the tree's trunk, but no corresponding uplift of the carriageway of Millbank itself.

Photo 5. View showing uplift of plinth & foundation at base of tree 71008.

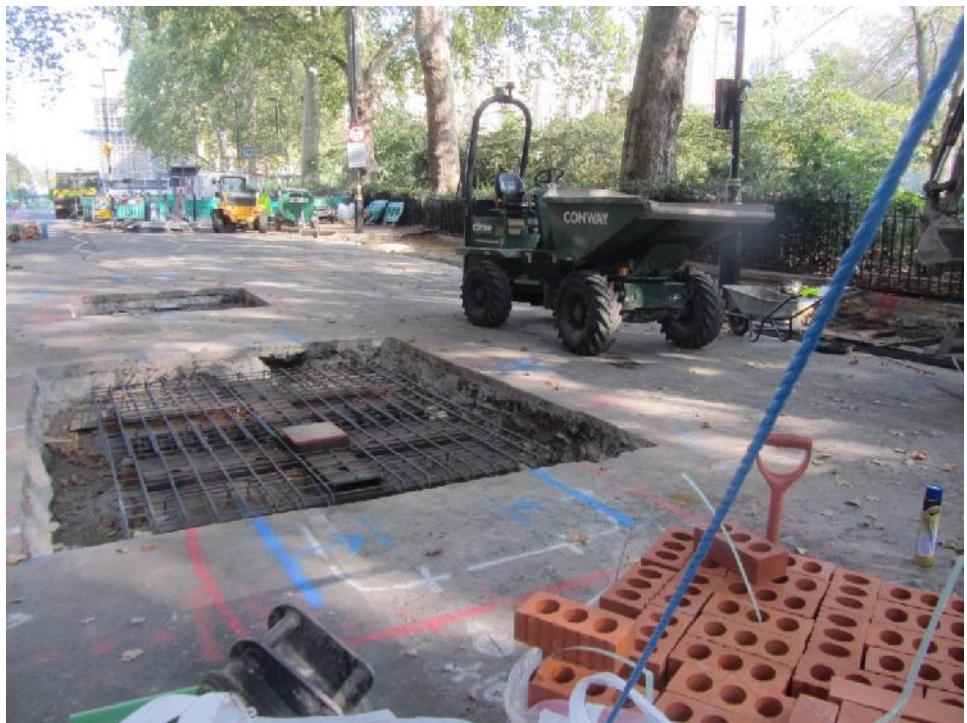
- 3.1.6 Two further excavations had been undertaken in the centre of the carriageway of Millbank itself, also to approximately 800mm. The southern pit was rectangular, estimated to be around 5m by 2.5m, with the northern pit being smaller and square, at around 2m by 2m (*Photo 6*). Similar steel foundation structures and reinforcement caging had been installed within them. Examination of the side faces of these pits reveals the sub-base of the roadway (the full depth of which had not been achieved by the excavations) to comprise a more homogeneous and densely compacted composition of layers of stone, concrete and other hardcore to the full depth of the excavations. I saw no root growth within these layers, nor projecting from the excavation edges into the pits, and no evidence of any severed root ends (*Photo 7*).

Photo 6. Excavations in Millbank carriageway, general view.

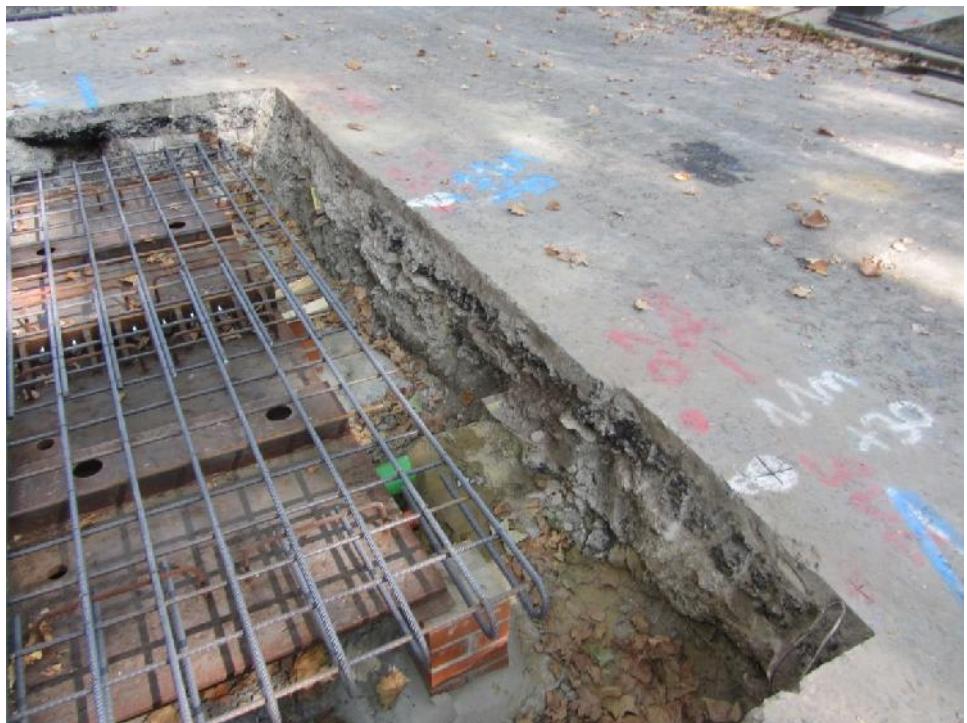
Photo 7. Excavation in Millbank carriageway, detail.

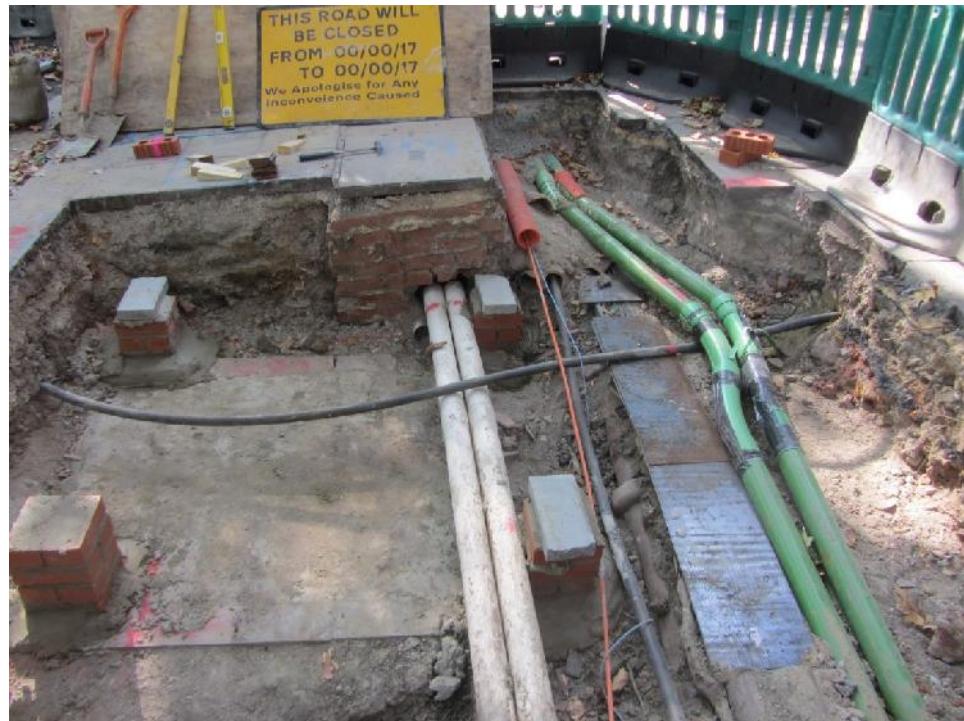
- 3.1.7 A further excavation had taken place within the footway on the opposite side of Millbank, approximately 3m northward of a street tree on the corner of Millbank and Great Peter Street. This also exhibited a composition and density of underlying

sub-base similar to that within the footway on the VTG side, with minimal root presence evident within 700mm of the footway surface.

Photo 8. Excavation on opposite Millbank footway from VTG

- 3.1.8 Only one broken root of around 20mm diameter was evident, to the left of the two pipes emerging from the brickwork inspection chamber in *Photo 8*. Several other service routes were also present in this excavation.
