Huguenot House

Review of Scope of Works

Westminster City Council

03rd November 2022

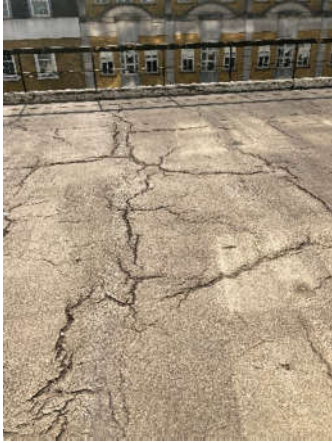
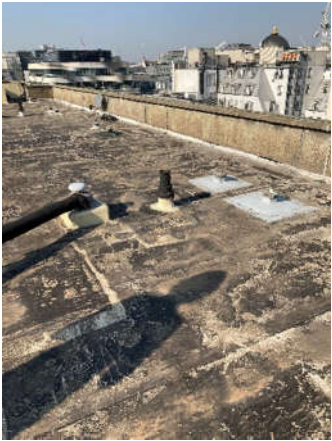
The existing asphalt roof surface to all areas is generally in a poor condition, with the podium roof to the Orange Street elevation suffering from the most progressed defects. The second podium roof and the tower block are also in a poor condition and works are required to be completed to prevent further deterioration.

The existing edge protection to the tower block roof is not compliant with statutory regulations and a new system must be installed as a result.

This value engineering exercise was completed ahead of the works being issued out to competitive tender. It is the recommendation of F+G that the proposed roof works included within the tendered SOW are taken forward.

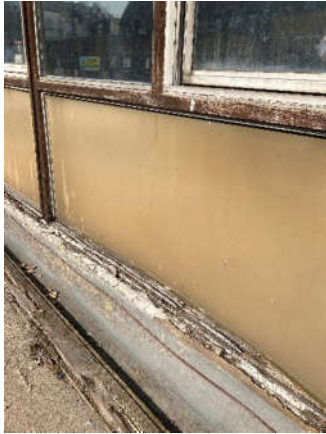
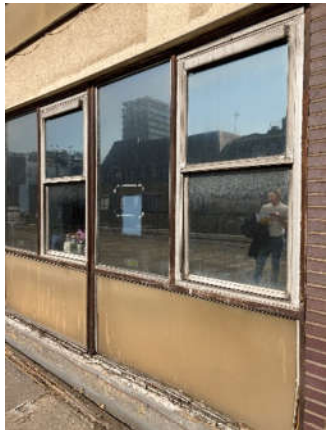
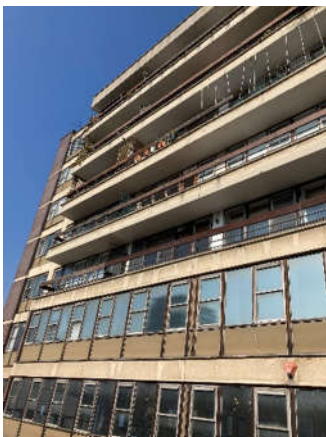
The existing single-glazed external windows that were inspected are in a very poor condition and have reached end of life. It is anticipated that windows at high level, that are unable to be inspected in more detail without the provision of specialist access equipment, will be in a similar state of disrepair. The rotten timber frames of the windows may also pose a significant H&S threat should glazing panels not be provided with adequate structural support.

It is the recommendation of F+G that the full-scale replacement of the windows to the tower block elevation is taken forward as a high priority element of work.

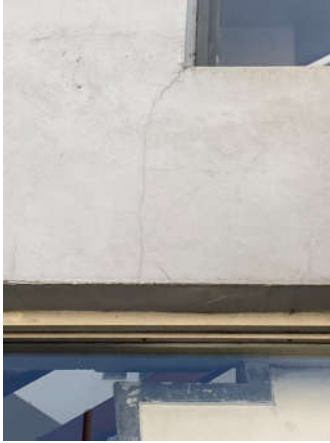
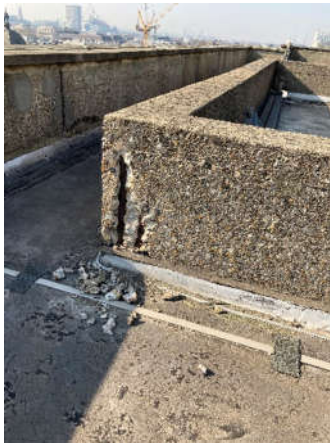
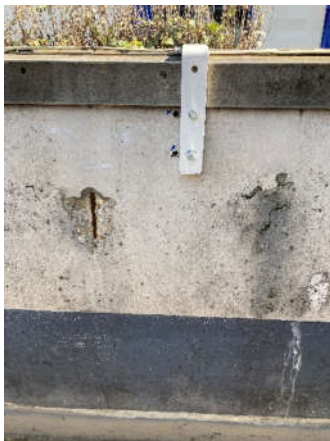
Loose render material is considered a significant H&S hazard to both the building occupants and general members of the public, as the render is located to all elevations of the building and over sails public footpaths and pedestrian areas in a densely populated community. It is the recommendation of F+G that the full tap-testing specification is completed, along with the subsequent repairs that are identified. This will not be able to be completed until the scaffolding has been erected in full to all external elevations of the building.

Although the condition of the external concrete render is already poor, this will continue to deteriorate if remedial works are not completed and the risk of loose material falling from the building will continue to increase.

The concrete and render repairs included within the proposed works have been specified and quantified by our structural engineering design team. It is proposed for a full programme of tap-testing to be completed to full area of the external render, with any loose material being removed. Concrete/render repairs will then be completed as required. Concrete repairs have also been identified to the parapet walls to the NCP car park area and the to the tower block roof.
