### Glastonbury House: Built in 1969

## End of Works Update

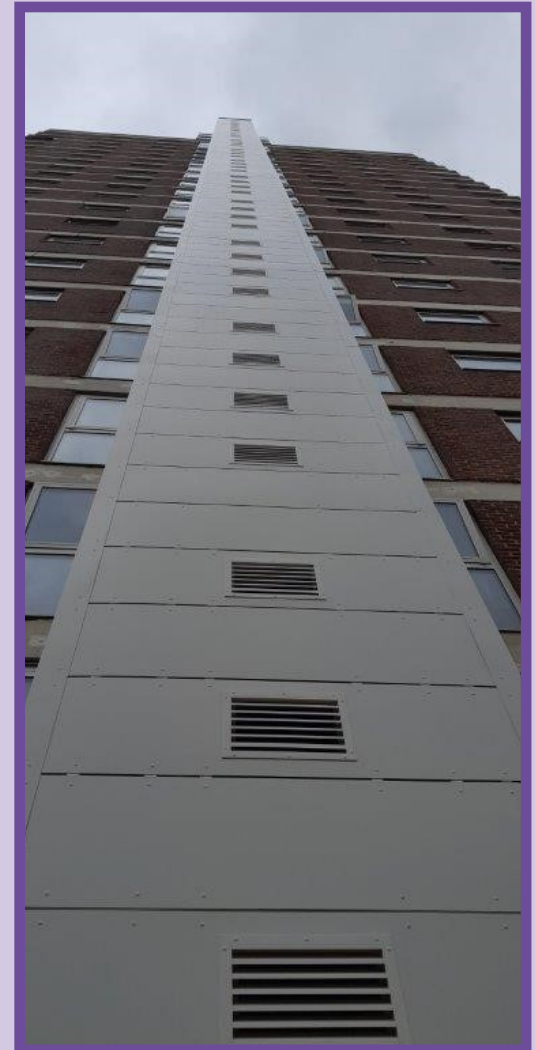
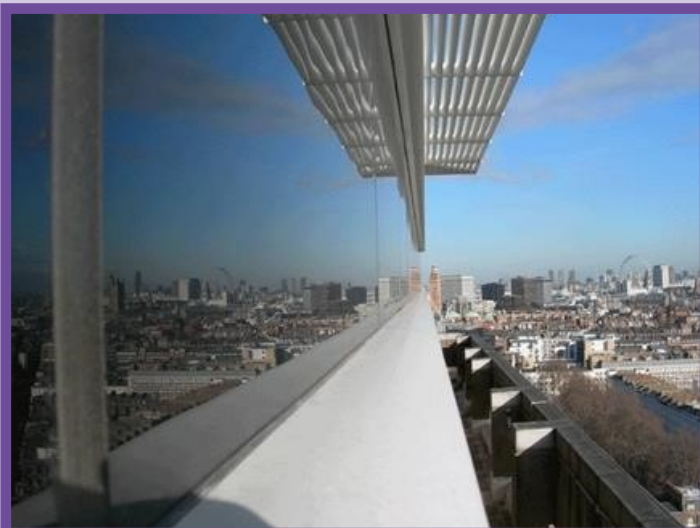
I think you will agree that the quality of finish is very good and the non combustible riser, all 66 metres of it, now looks very smart.

The structural load bearing steels have been painted with an Intumescent coating to provide a passive fire protection. (An intumescent coating is basically a paint-like material which is inert at low temperatures – under 200 °C, but reacts with heat. As the temperature rises, during a fire event, the intumescent coating swells and forms a char layer that covers the steel.
