# GEOPHYSICAL SURVEY REPORT

**Victoria Tower Gardens,  
Westminster, London**

Client  
**Atkins Ltd**

Survey Report  
**11461**

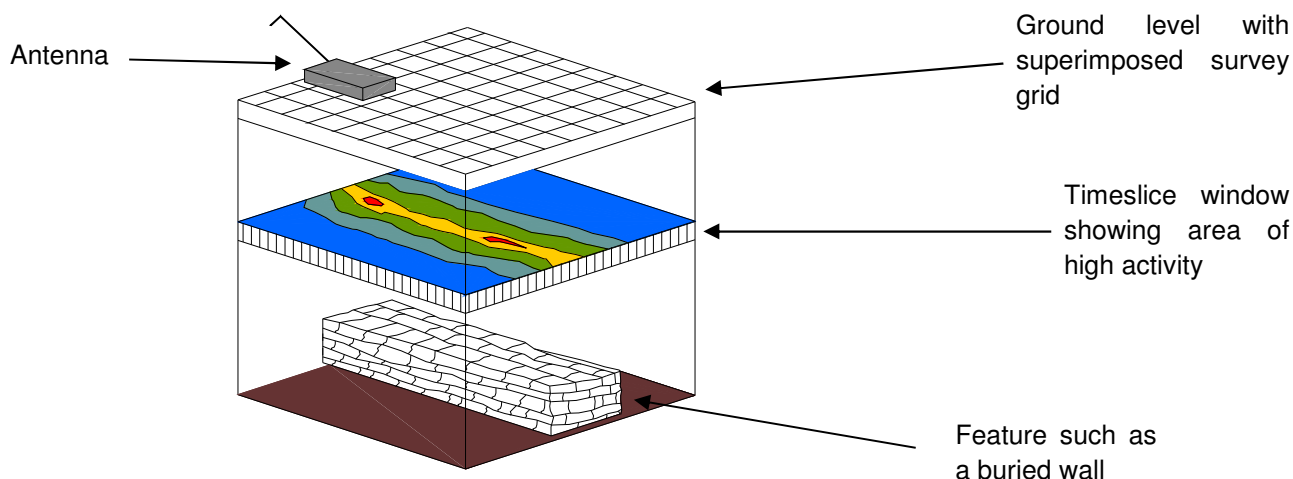
The radar data is interrogated for areas of high activity and the results presented in a plan format known as timeslice plots. In this way, it is easy to see if the high activity areas form recognisable patterns.

The GPR data is compiled to create a 3D file. This 3D file can be manipulated to view the data from any angle and at any depth within a range. The 3D file can be sampled to produce activity plots at various depths. As the radar is measuring the time for each of the reflections found, these are called "time slice windows". Plots for various time slices have been included in the report. Based on an average velocity calculations have been made to show the equivalent depth into the ground.

The weaker reflections in the time slice windows are shown as light grey colour. The stronger reflections are represented by colours such black and dark grey.

Reflections within the radar image are generated by a change in velocity of the radar from one medium to another. It is not unreasonable to assume that the higher activity anomalies are related to marked changes in materials within the ground such as foundations or surfaces within the soil matrix.

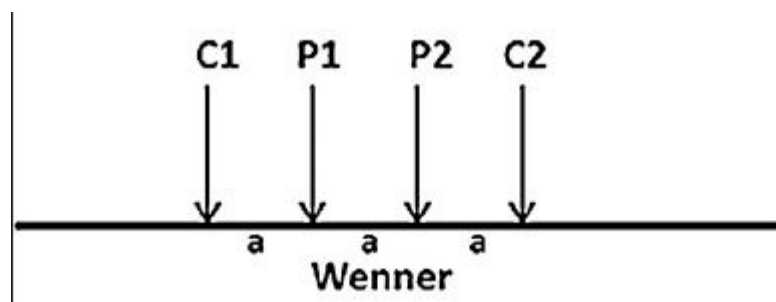
*The above image shows the schematic layout of the Wenner electrode configuration. This has an equispaced distance between each of the electrodes (a). The current is injected via the outer electrodes (C1 and C2) and the potential difference (voltage) measured between the inner electrodes (P1 and P2).*

The data has been collected using the Wenner electrode configuration. Spacing between electrodes (a) varied between each survey line with respect to total survey line length and desired resolution of data and penetration depth.

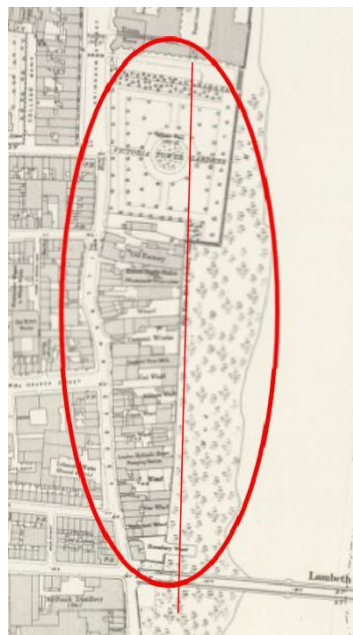
*1893 OS map with the north-south inferred line overlaid clearly following the mapped foreshore (within the inaccuracies expected).*

Scattered across the site, but predominantly in the central area are numerous smaller complex GPR responses. These anomalies seem sporadic and do not form a recognisable regular pattern. They do correspond with an anomaly in the EM data. It is possible to speculate that they may relate to structural remains of the many buildings that have stood on the site particularly from the 1700s through to the creation of the gardens in 1879. This is of course tentative at best and is based purely on circumstantial evidence. It is interesting to note that less of these types of response are seen in the east of the site which is known to be reclaimed land. Perhaps this concentration of anomalies can be used to infer a line demarcating a previous foreshore or wharf. This line has been speculatively drawn on the GPR interpretation figure. Other responses seen in the EM data also seem to obey the edge of this line adding further evidence which does suggest a distinct change is occurring at this point. The historic maps support this in depicting that the shore line is further west than its present location. It is not possible to georeference many of the older historic maps to the current landscape and so a direct comparison of the positions is not possible. The 1893 OS map can be overlain to the current landscape and shows that the inferred boundary aligns well with the mapped Victorian shore line.

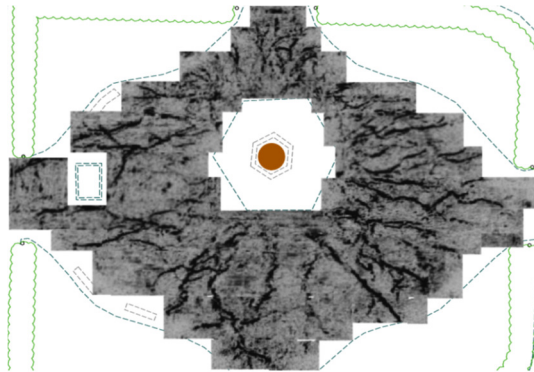
*Example GPR timeslice showing tree root pattern radiating out from a central tree.*

No clear radiating patterns have been detected adjacent to any of the trees present (an example of what this can look like is shown below). Some weak linear anomalies are observed around the extremities of the site. These are predominantly located along the western edge of the site. Whether these are due to roots or simply noise as a result of footpaths in these areas is unclear. This suggests that the roots radiating from these trees have a narrow diameter which can not be resolved by the radar. It is possible that the majority of the roots radiate away from the gardens. Although given the proximity of growth restrictions in other directions (Millbank built environment on one side and the river wall and brackish water of the Thames Tideway on the other) this seems unlikely.

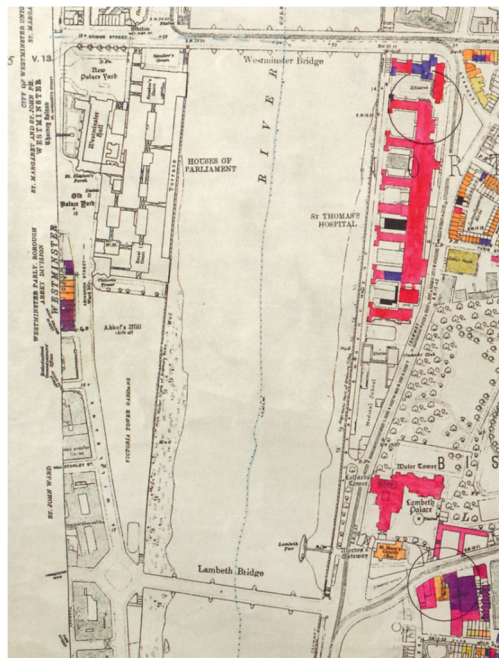
*London County Council Bomb Damage Map, c.1945 (Ward, 2015).*

The bomb damage map above shows buildings that have been totally destroyed (purple) adjacent to the site on Millbank. On the opposite bank buildings can be seen that have been seriously damaged (red). This clearly demonstrates that the site is within an area subject to air raid and as such has potential to contain UXO.

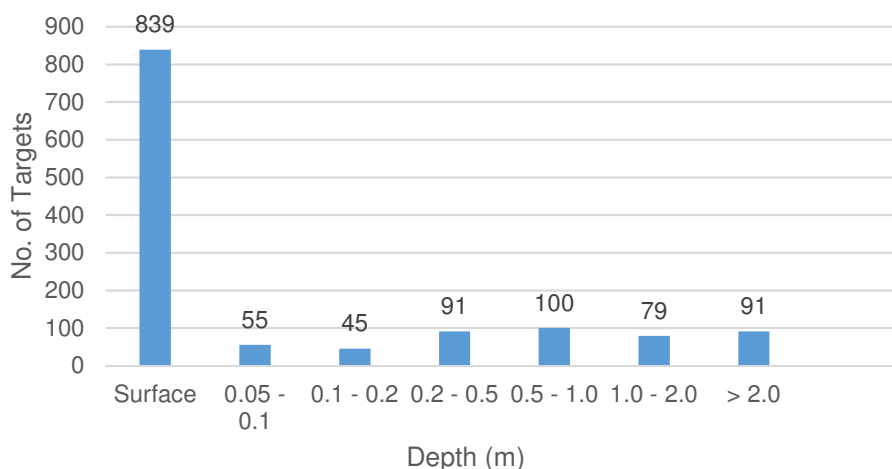
### Distribution of Targets by Depth

The number of anomalies is determined by performing a Blakely test on the electromagnetic data which determines targets. To assess anomaly mass, the relative field strength between each coil on the EM61 is used.
